AFML-TR-76-173

## EXPLORATORY DEVELOPMENT ON DURABILITY OF ADHESIVE BONDED JOINTS

BOEING COMMERCIAL AIRPLANE COMPANY  
P.O. BOX 3707  
SEATTLE, WASHINGTON 98124

TECHNICAL REPORT AFML-TR-76-173  
FINAL REPORT FOR PERIOD FEBRUARY 1974 - OCTOBER 1976

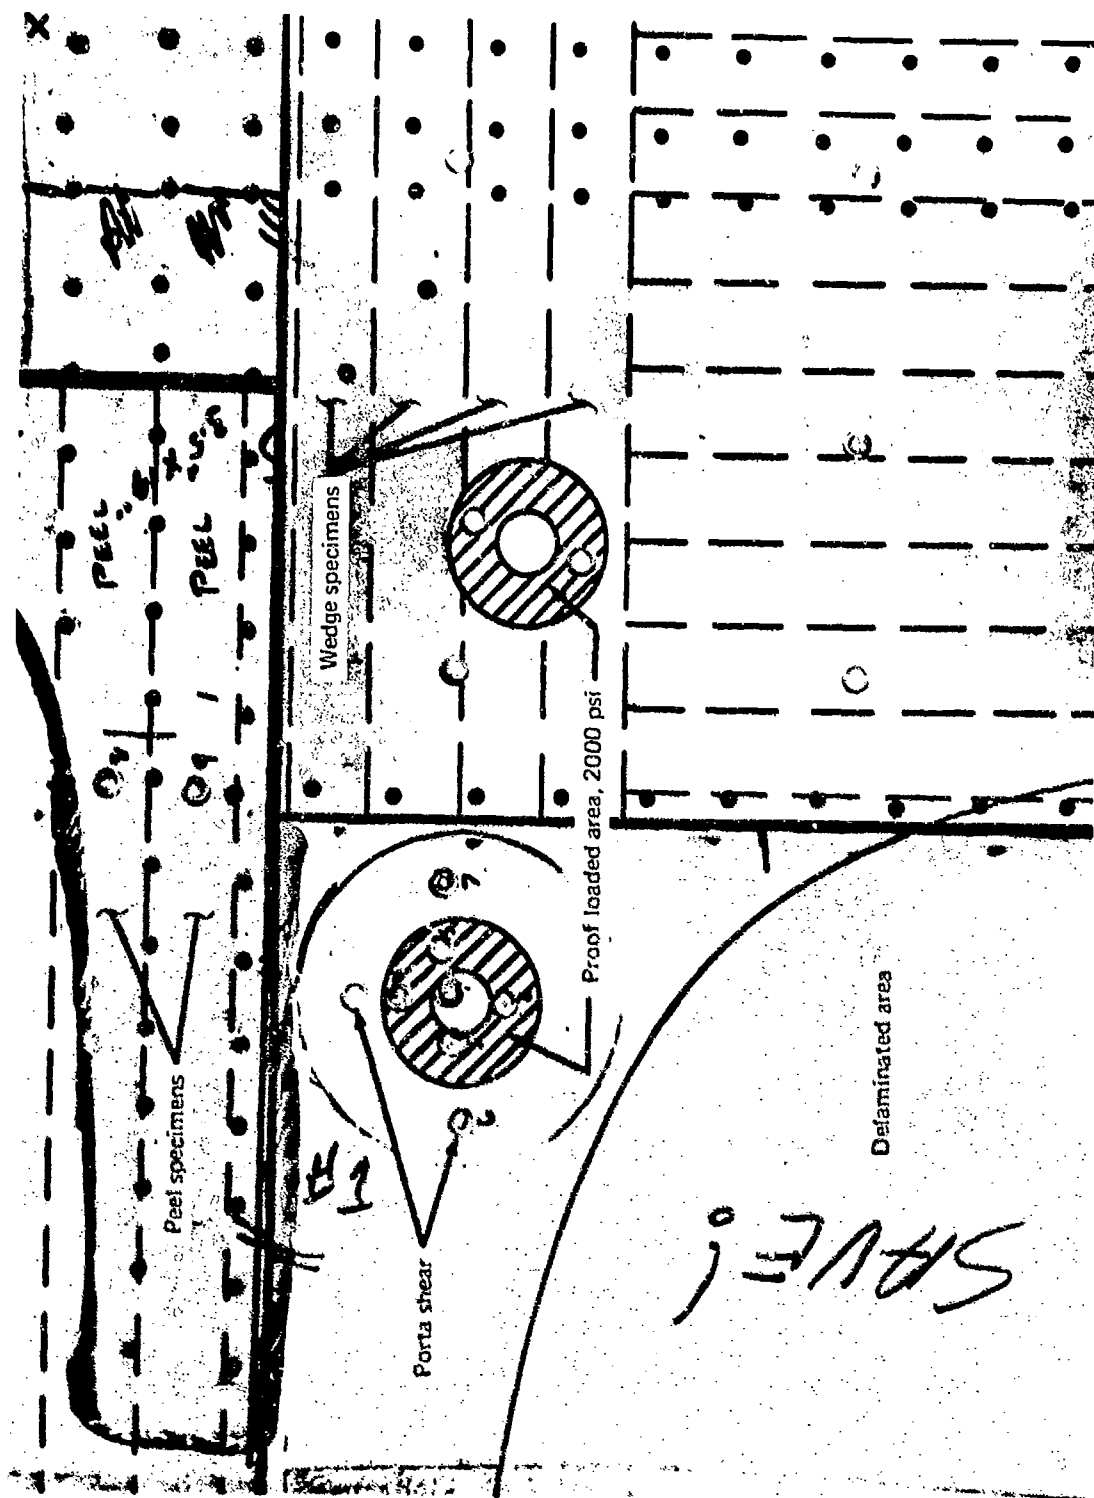
Figure 40.—Section of Aircraft C Component Showing Areas Where Test Specimens Were Taken

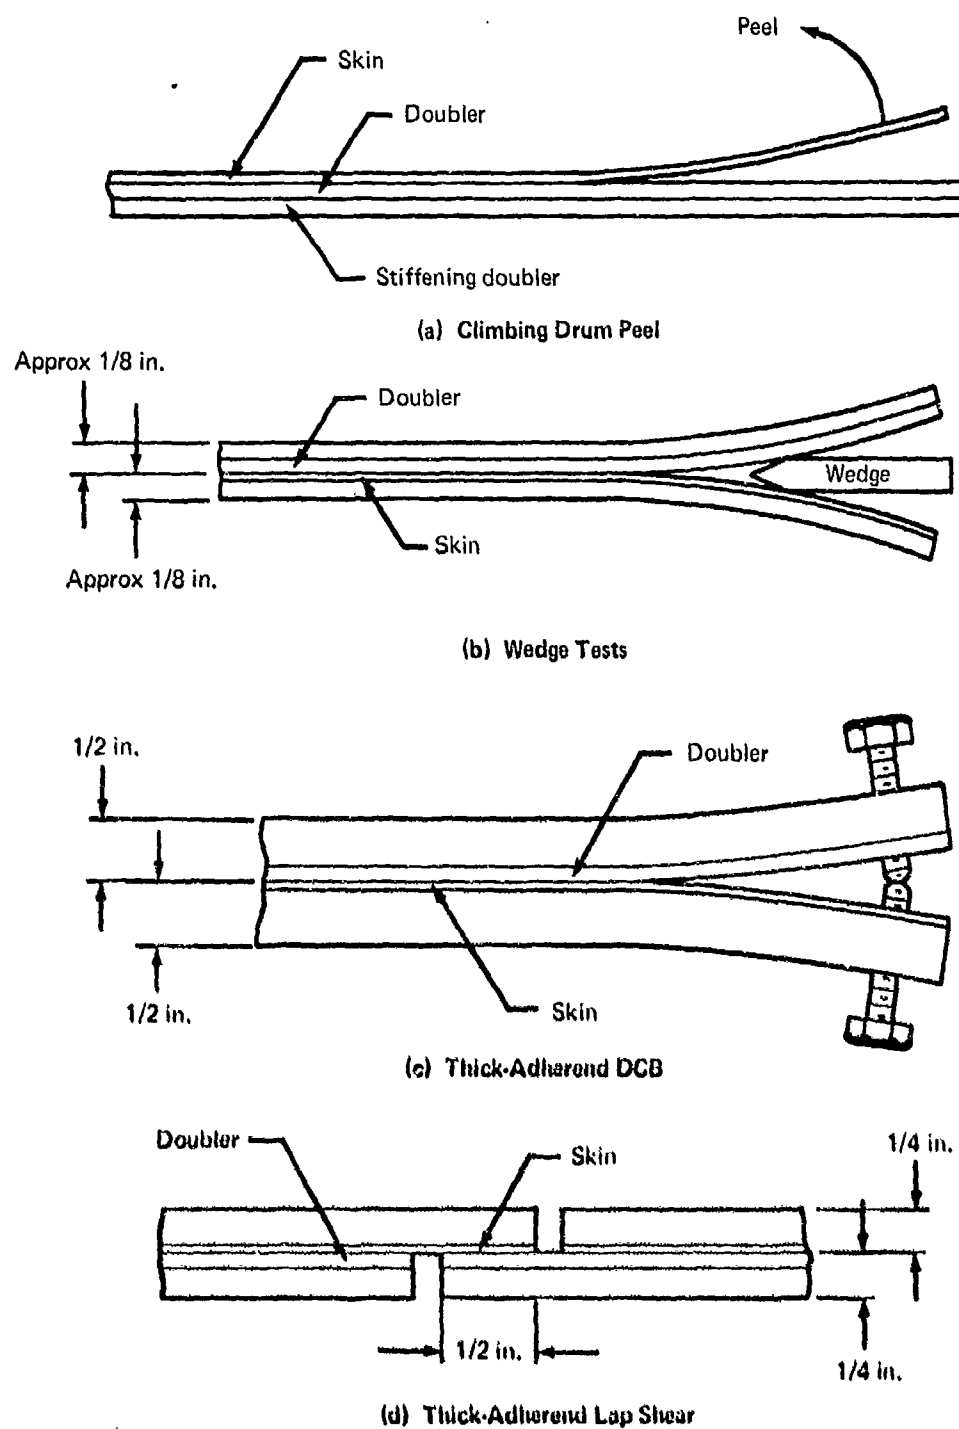
Figure 45.—Configurations of Specimens Fabricated From Air Force Aircraft Details

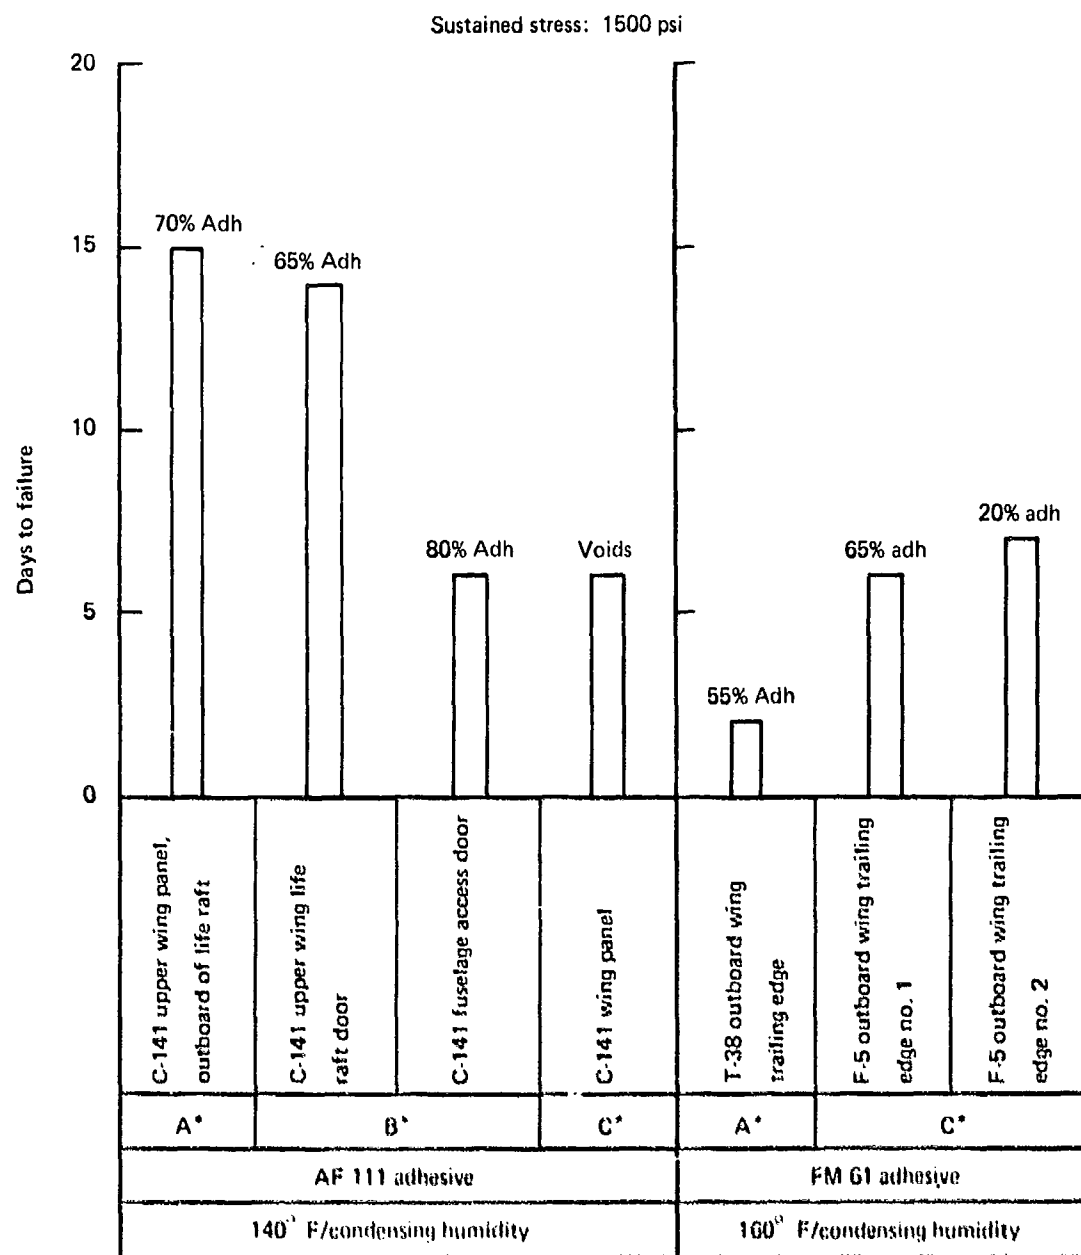
Figure 47.—Sustained-Stress Thick-Adherend Lap-Shear Time-to-Failure Results

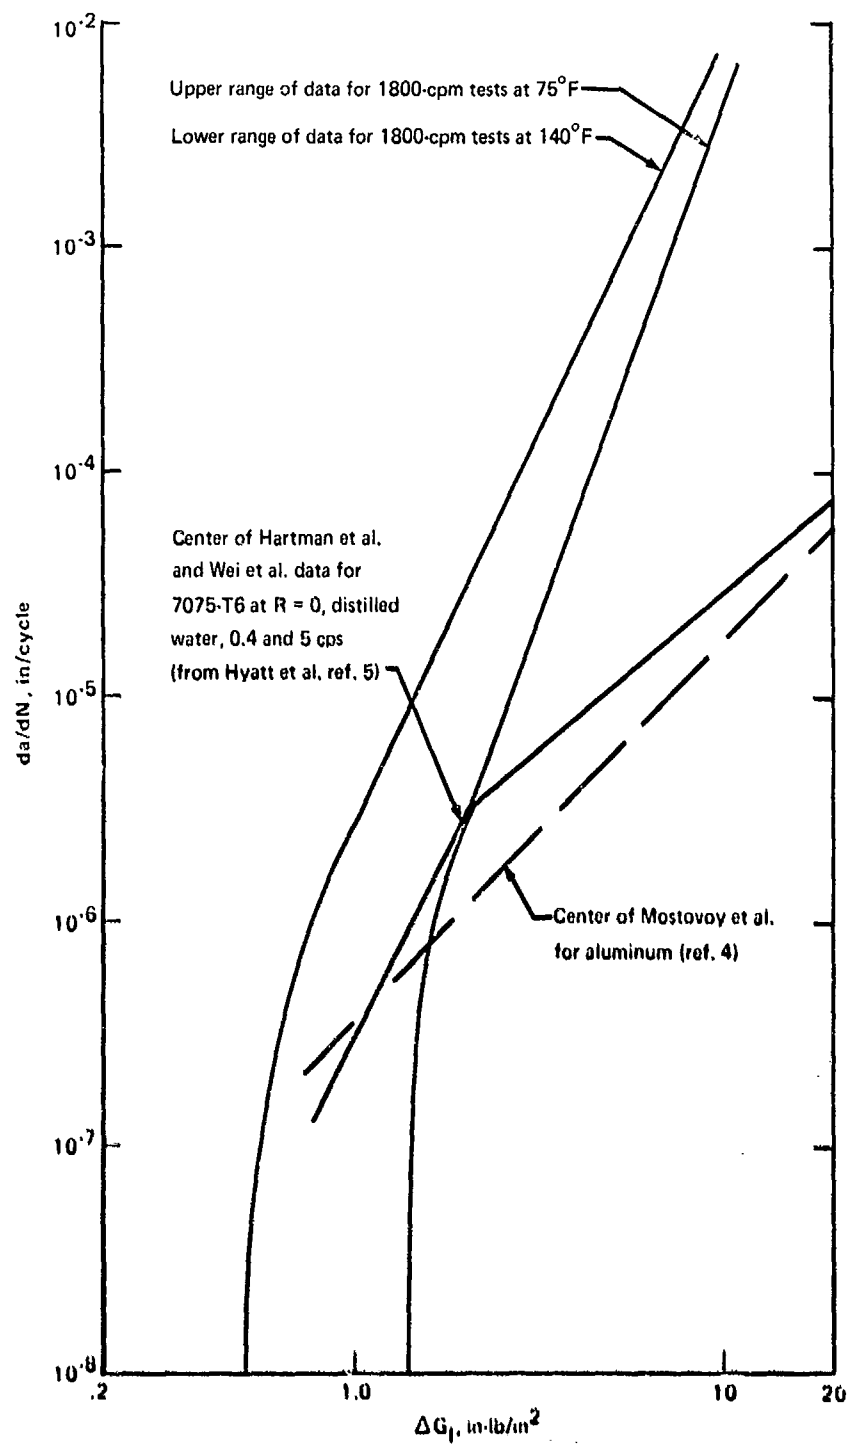
Figure 48.—Comparison of Bonded Aluminum Fatigue Crack Growth Data With Published Data for Fatigue Crack Growth in Aluminum Alloys

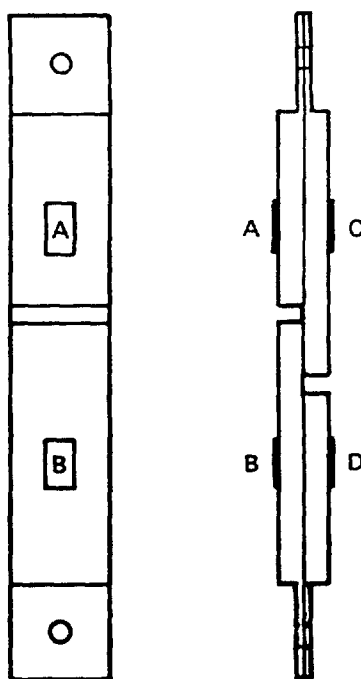
*Figure B-2.—Strain Gage Location on Thick-Adherend Lap-Shear Specimen*

Each of the four specimens was tested on two different tensile test machines to determine strain behavior under conditions of known uniaxial loading. These two machines were a Tinius Olsen 30 000-lb tensile tester and a 20 000-lb Instron Universal. Tests were made by incorporating the clevis tie rods from the jig into the test fixture and substituting wider clevises requiring a longer pin for the jig clevis tie rod.

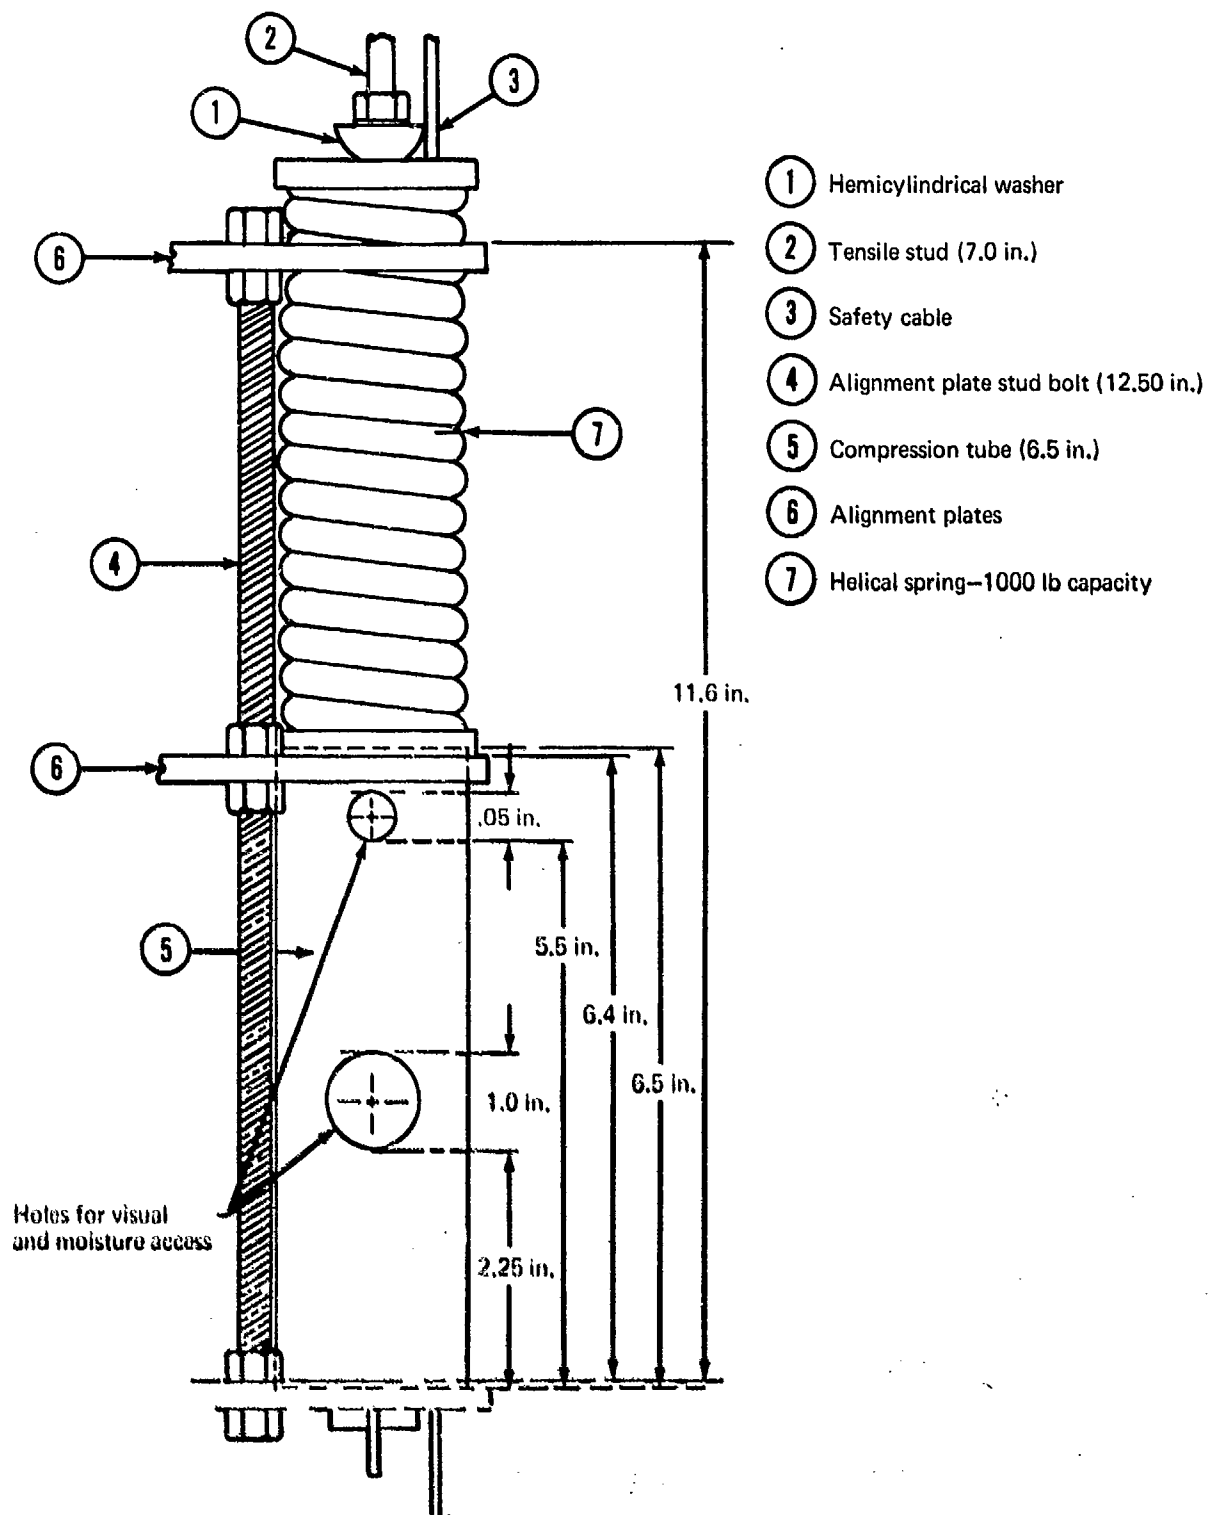
In keeping with these objectives, the tube was lengthened to contain the entire specimen, a second alignment plate was added and the distance between the two alignment plates was set to maintain both ends of the spring, a hemicylindrical washer was installed between the nut and bottom plate, and the safety bolt was replaced by a cable. The modified fixture is shown in figure B-3.

Figure B-3.—Thick-Adherend Lap-Shear Modified Loading Fixture

Three specimens for each system were loaded at two different levels (900 and 1500 psi) in the modified testing fixture (note app. A) shown in figure 6. The stressed specimens were exposed to a 140°F/condensing humidity environment for 140 days. (The test period was limited by the contract duration). One of the environmental chambers with loaded fixtures is shown in figure 7. Time to failure was recorded for those specimens that failed. Those that did not fail in the 140-day period were tested for residual shear strength at room temperature. Time to failure and residual shear strength results are given in tables 5, 6, and 7.

A prototype of this modified fixture was made as shown in figure B-3 except that two existing tubes were stacked together with a separator plate between in place of the single 6.5-in. tube shown. The gaged specimens were tested in this modified jig, and their orientation within the fixture was equivalent to that shown in figure B1, except for the specimen being contained within the tube. Strains indicated from four separate loadings to a nominal 750 lb in the modified jig are shown in table B-2. Loads 1 through 4 represent loadings of the modified fixture in a manner equivalent to the usual method of loading the fixture.

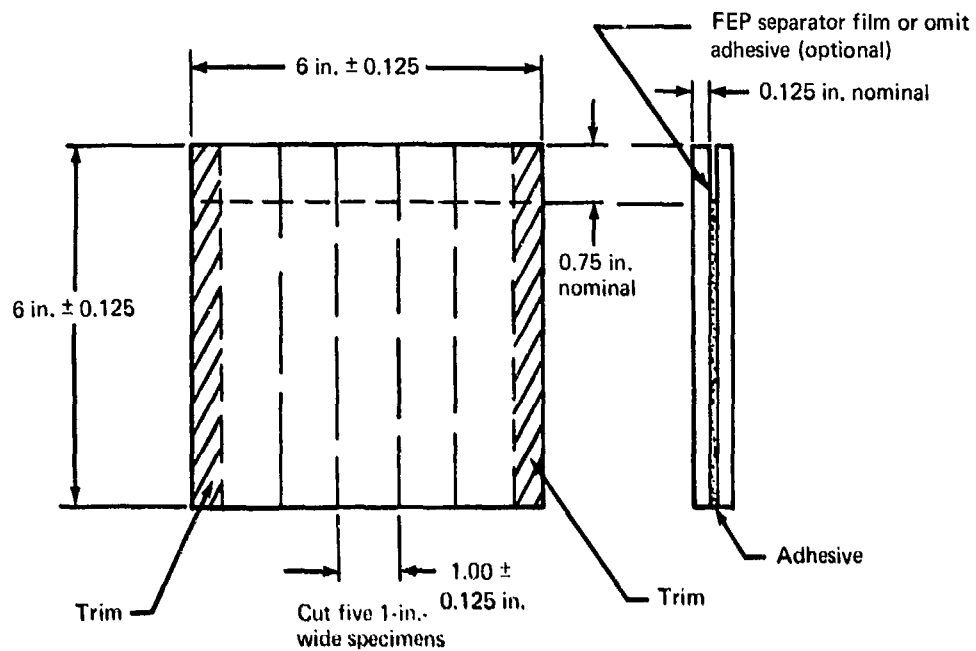
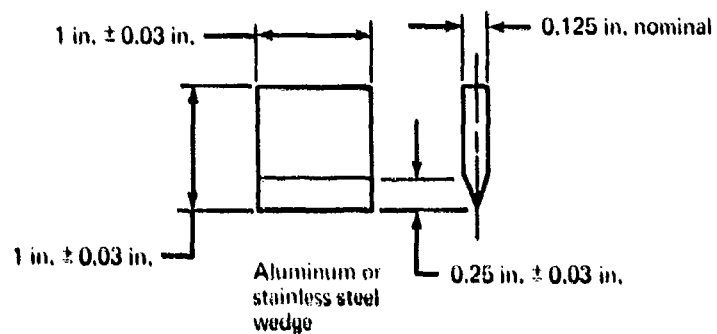
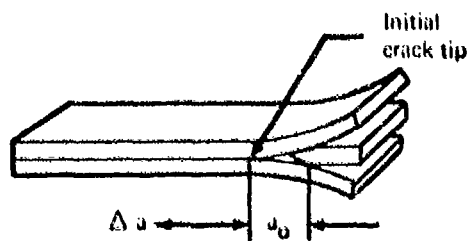
Wedged Crack Extension Specimen (The end and sides of the wedge shall be approximately flush with specimen end and sides.)

Figure C-1.—Crack Extension Specimen Configuration

5. Crack one end of each test specimen by inserting a wedge as shown in figure C-1. Insert the wedge by using a pushing force or several relatively light taps with a hammering device. *DO NOT* insert the wedge with a single striking blow. When inserting wedge, *DO NOT* hold specimen in any way that will restrain the initial cracking. Position the wedge so that the blunt end and sides are approximately flush with those of the specimen. (In any use of an auxiliary tool to precrack a test specimen to facilitate insertion of a wedge, the extent of precracking must be less than that which is caused by insertion of the wedge.)

6. Using 5 to 30 power magnification and adequate illumination, locate the tip of the crack on the 125- $\mu$  in. finish edge of each specimen. This is the point farthest from the wedge where the specimen (the adhesive, primer, and/or adherends) has separated. Using a fine stylus or scribe, mark the location on one adherend edge. If the specimen is to be used in salt spray or other environment expected to be corrosive and liable to obliterate the mark, deepen the scribe mark with a triangular file.
